CERTIFICATE OF COMPLETION & REPORT

Project Description: Cooling Tower Disinfection with Basin Cleaning at

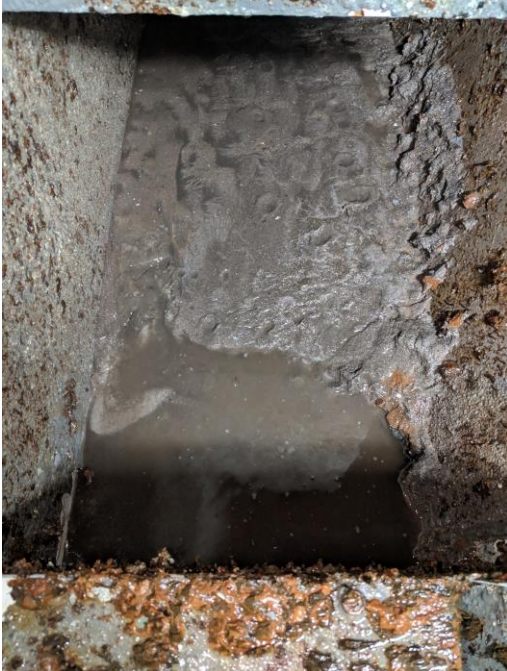
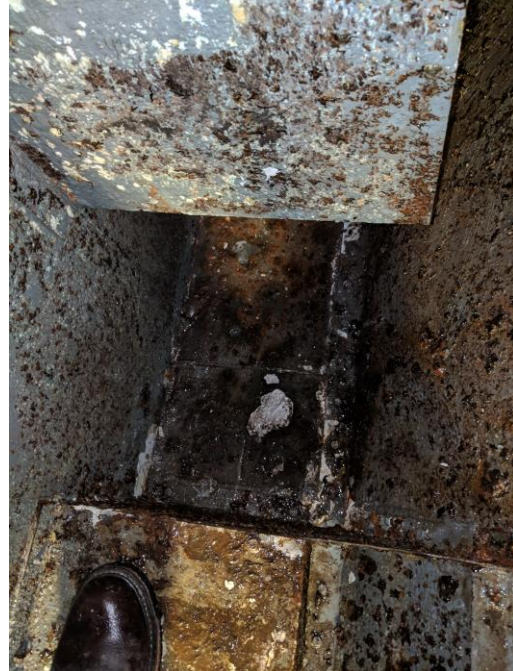
Before and After of the Basin Cleaning

On the next day, the tower was drained down. The cold-water basin was vacuumed of all collected mud and loose debris that was gathered. All debris was disposed. The surrounding work area was cleaned.

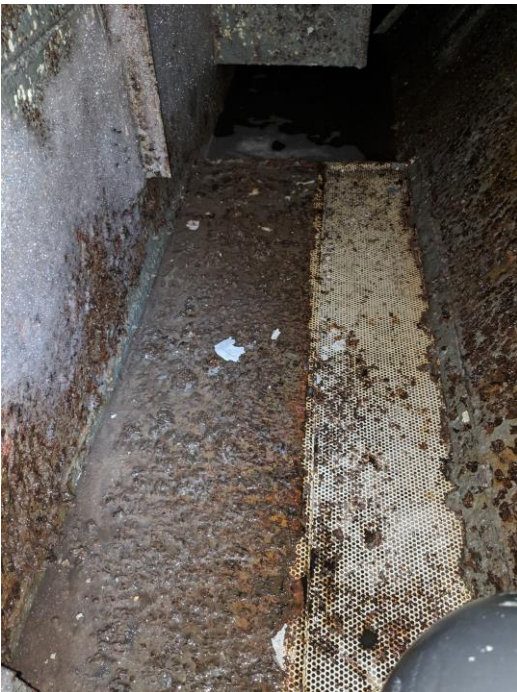
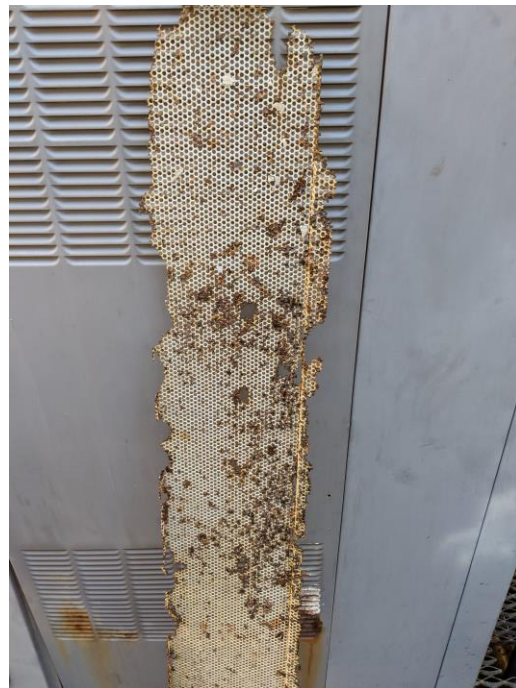
The intake screen for the pump housing is almost corroded through and will need to be replaced. There is also a decently sized hole on box around the pump intake that should be patched.

A Couple Views of the Intake Screen Corrosion

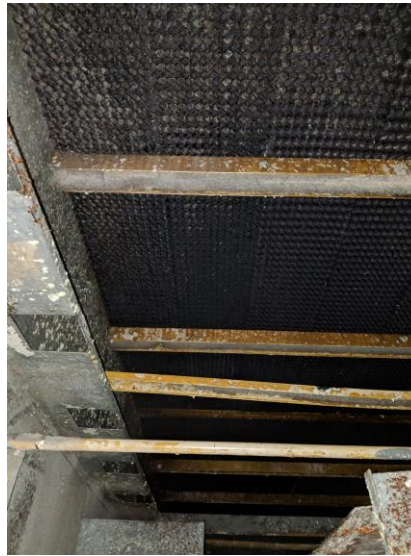
Media is in good condition on both top and bottom. There is some build-up on both sections and a full clean of the fill inside the tower and the drifts at the top. If treatment is well maintained, there should be no need to replaced the media for at least 2 years.

Media is in good shape only mild build up apparent.

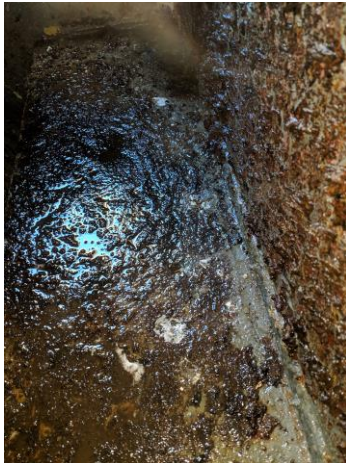
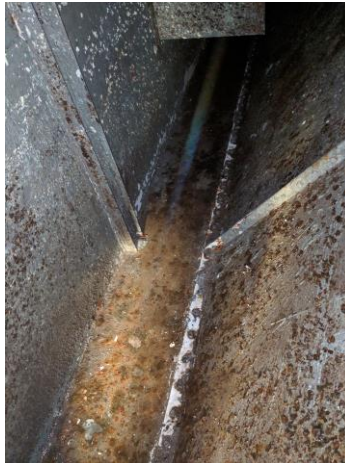
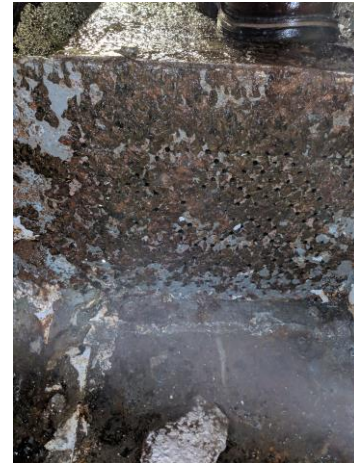
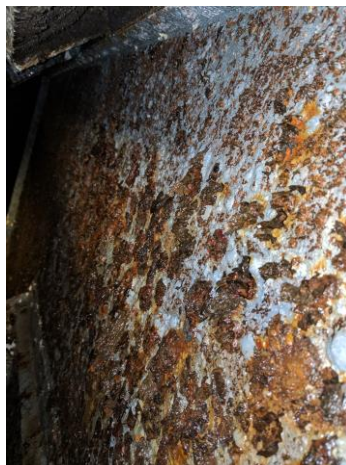
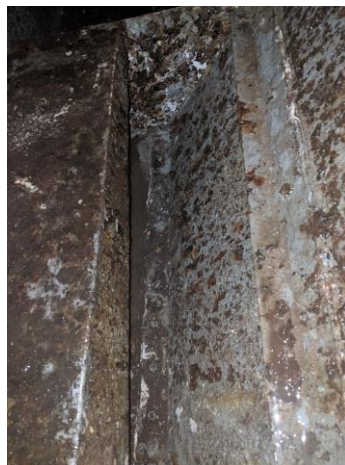
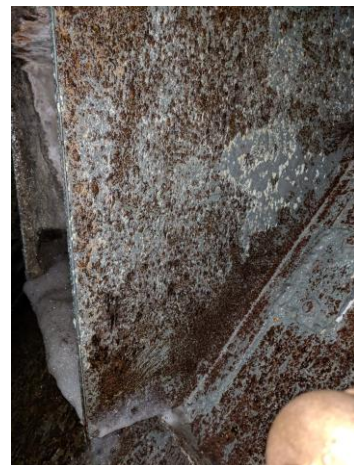
The entire internal of the tower looks to be heavily corroded on most metal surfaces. If coated soon, there should be enough metal left to apply a durable surface.

Several pictures of the heavy corrosion in the tower
