## CERTIFICATE OF COMPLETION & REPORT

Cooling Tower Top Replacement – With Coating  
[REDACTED]

Work Completion: Oct 25-27, 2019

Tower Top Replacement  
Close Out Report

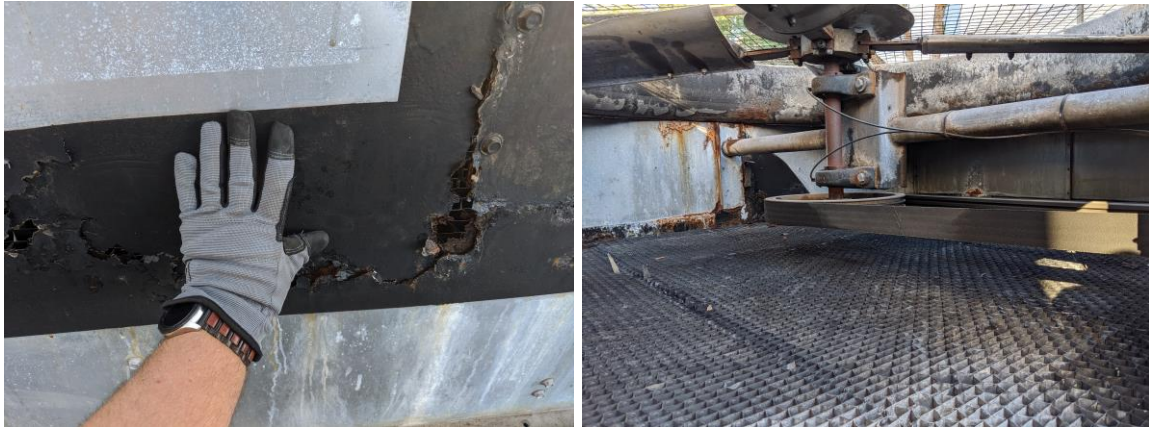
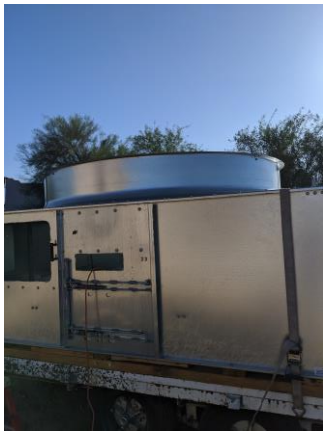
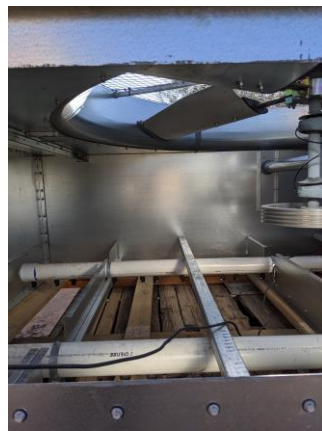
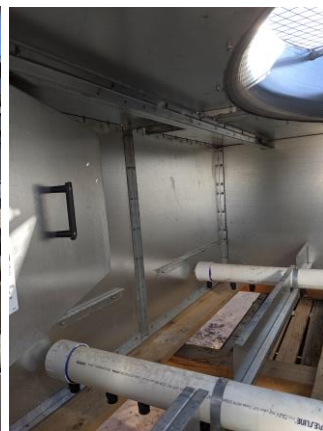
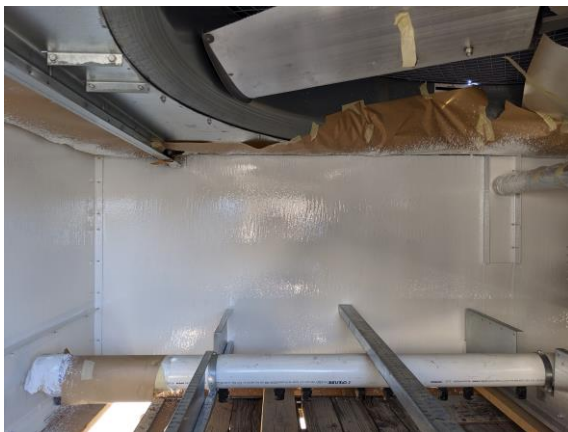
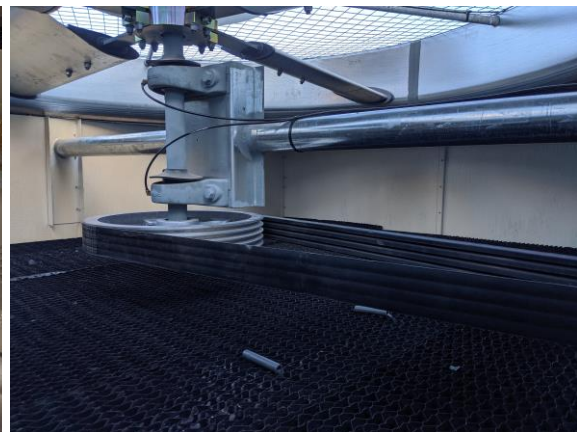
Existing Drift Casing section (top), New Drift Casing as delivered (middle), New Drift Casing with coating (bottom).

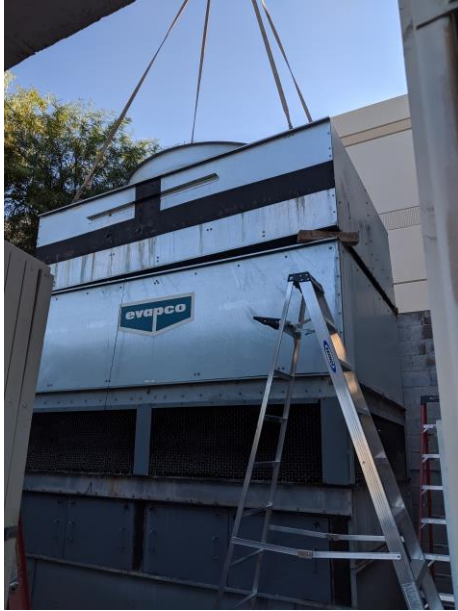
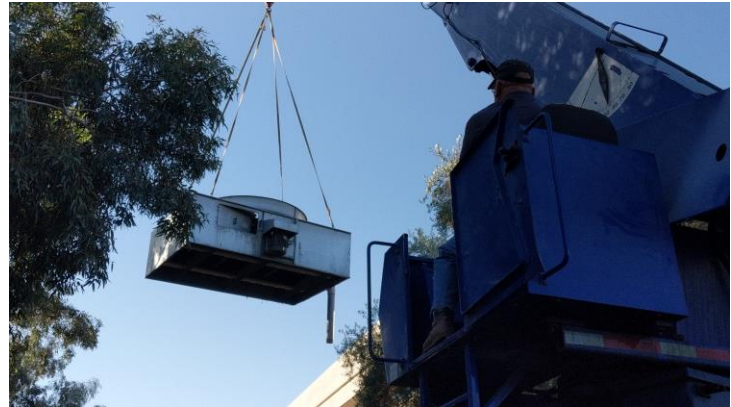
Tower was separated and craned off

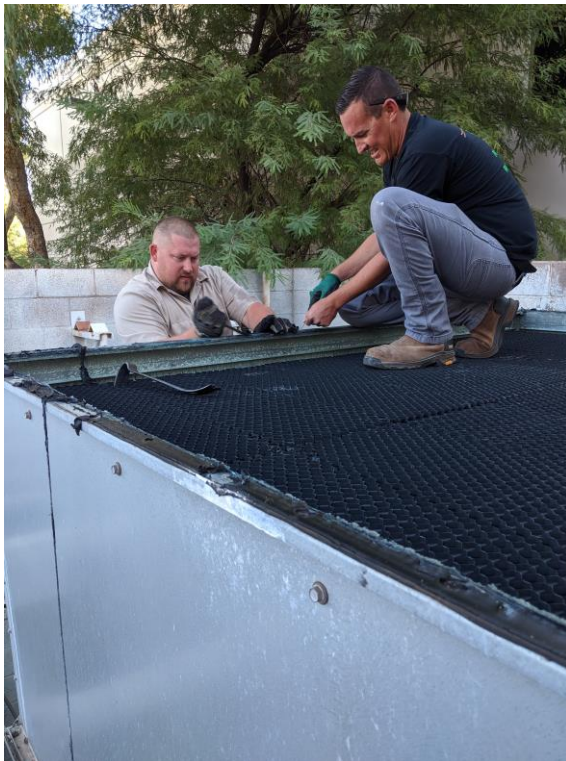
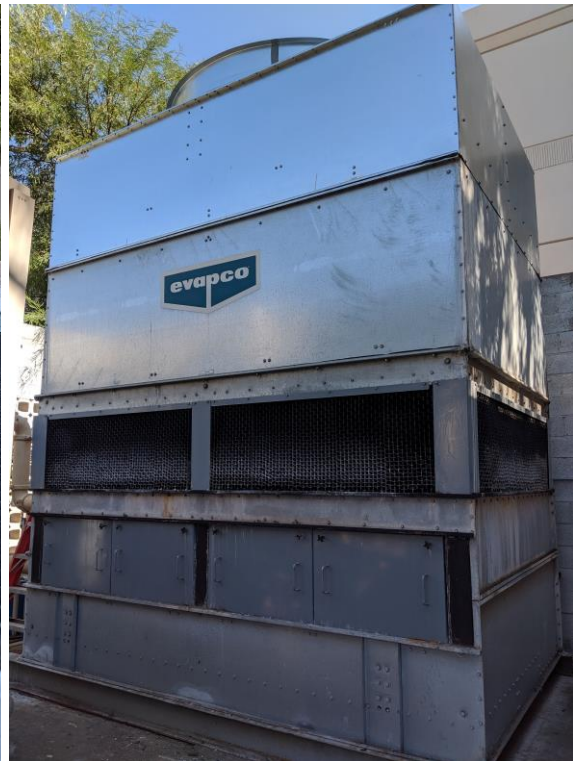
Old sealant was removed and replaced with fresh sealant before the new top was set in place.
